AUDIT REPORT

Alliance for Water Stewardship (AWS)

Audit Number: AO-001275

Site: **Dynamic Electronics (Kunshan) Co., Ltd.**

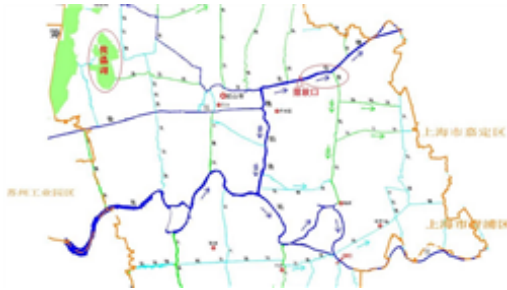
wusong river catchment.jpg

For discharged water, the factory adopts the principle of 'Separation of rainwater and wastewater', and the different discharged water flows into different pipeline. The rainwater is discharged into the municipal rainwater pipeline and then finally flows to Tongxin River. The industrial wastewater is treated by onsite wastewater treatment plant only, and then emitted into the Taicangtang River, and flow into Lou River, a tributary of Wusong River.

All of the above places are located in the Wusong River catchment.

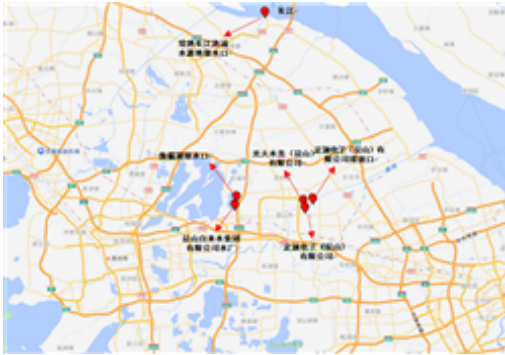
water source and discharge point.jpg

DE only used municipal water and the recycle water. The municipal water is for domestic and production use, and the recycle water is for production used. The municipal water plant has two sources. One is Kuilei Lake, which is small branch of the Lake Taihu, and the other one is from Yangtze River Diversion Project.

The domestic wastewater is discharged into municipal wastewater treatment plant, and then finally flows to Taicangtang River.

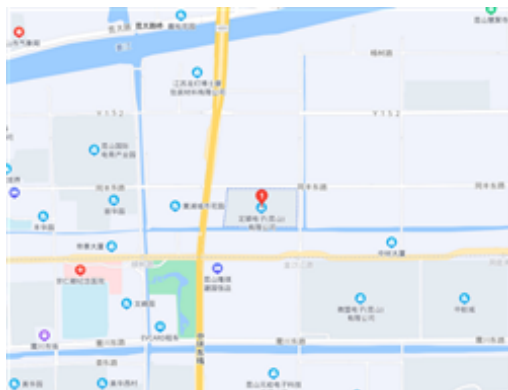
site map and surrounding.jpg

DE developed a site boundary map, which identifies the site boundary information and the layout within the site.
DE also collected information on the location of the on-site ETP, industrial and domestic wastewater outlet and rainwater outlet, chemical warehouse, hazardous waste warehouse, etc.
The rainwater and sewage pipeline network diagram are available, and the transportation pipelines for rainwater, domestic wastewater, and industrial wastewater are all identified and mapped.
DE also developed its catchment report including the location of the receiving water body, the location of water service providers and their water sources.
